**Oil & Natural Gas Corporation Limited (ONGC) are in the process of re-developing Mumbai High South field. The well-developed field has an extensive infrastructure of well head platforms, process platforms and pipelines. As part of Mumbai High South Field Redevelopment Phase-III, NauticAWT was engaged to carry out underwater repairs and pile remedial work on a number of platforms.**

**The Scope**

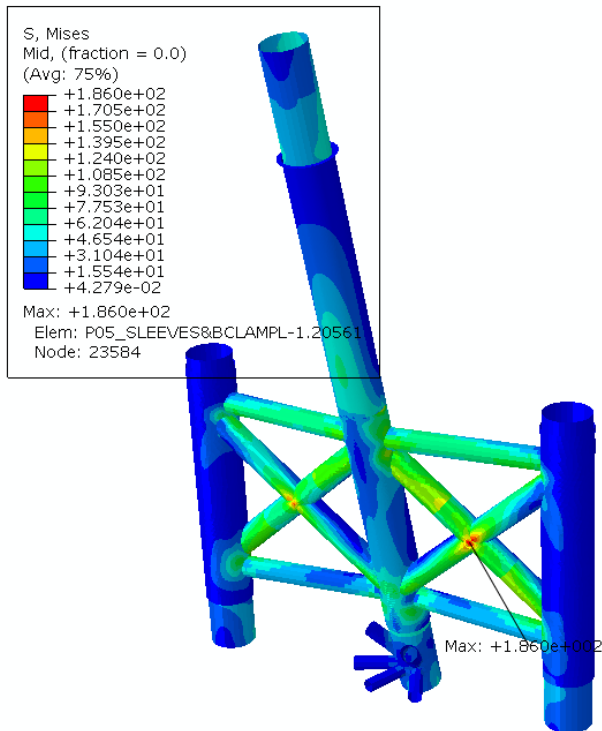
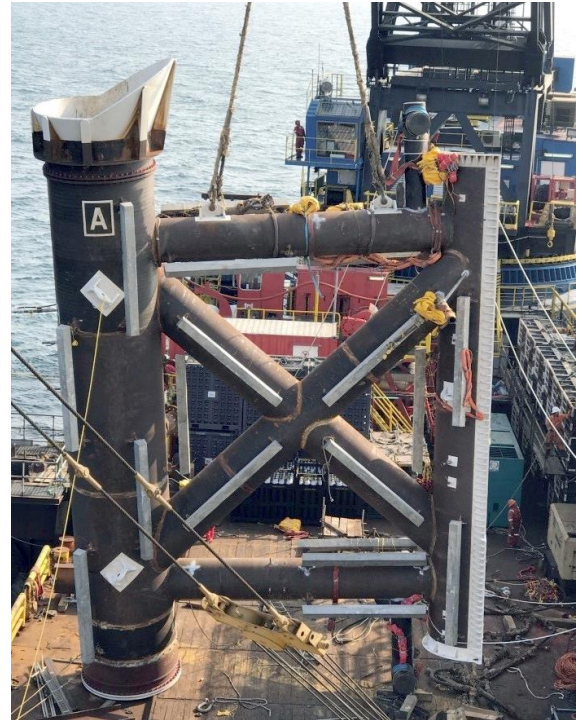
- **Pre-Engineering Survey:**
  - Pre-Engineering Survey Procedure for NU, SJ, WI-9 and D1C platform
- **Design and Detail Engineering:**
  - Structural strengthening analysis and design for NU, SJ, WI-9 and D1C platform based on field inspection data.
  - Structural design basic, In Place Re-analysis and Finite Element Analysis
  - The D1C clamp was designed to facilitate the installation of two skirt piles for pile remedial works at D1C platform.
  - Fatigue Analysis for strengthened joint A2 leg of D1C platform
- **Grouting Work:**
  - NU Platform:  
The NU platform underwater jacket member strengthening work involved the strengthening of a horizontal bracing member at EL (-) 7.00m. A total of 9 tons of NaX™ Q110 was consumed on this operation.

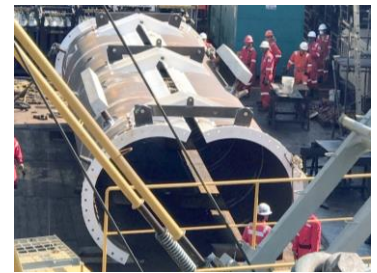
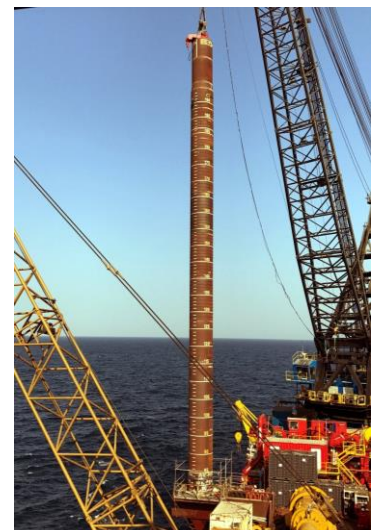
The scope of this underwater jacket member strengthening operation involved the strengthening of five members and a total of 98 tons of NaX™ Q140 grout material was used for this infill member grouting work.
